RAILWAY INVESTIGATION REPORT

R04Q0016

MAIN-TRACK DERAILMENT

MILE 62.4, LAC-SAINT-JEAN SUBDIVISION

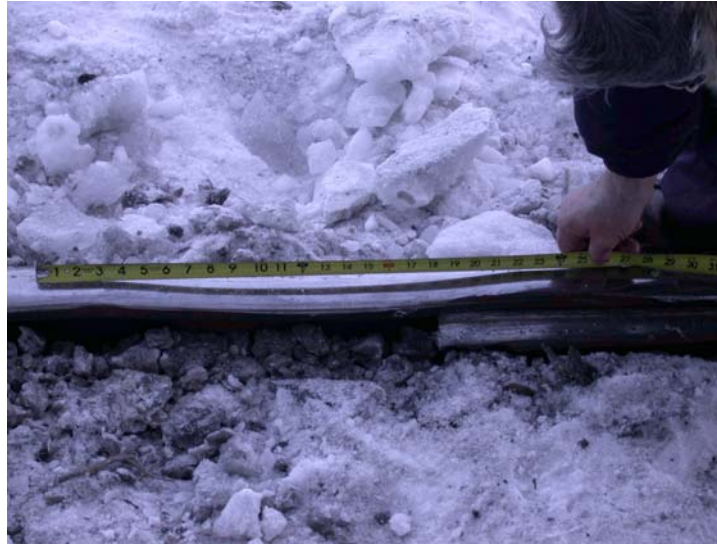
The rail was rolled in 1952, but there is no documentation indicating where it came from or when it was laid. Vertical rail wear was 9 mm and lateral wear was 5 mm, exceeding the wear limits prescribed by SPC 3200 for jointed rail, which are 8 mm for vertical wear and 13 mm for combined (lateral and vertical) wear. The rail had a crushed head (see Photo 1) 10 mm in depth located 410 mm from the north rail joint and about 1 m from the rail fracture.

Photo 1. Crushed rail head

The crushed rail head was not noted in the bi-weekly inspection records. The TSR do not define a crushed rail head as a defect. It is considered a defect in SPC 3207 when the depth reaches 10 mm, but no corrective action is required.

3. The age and wear of the rail and the presence of the crushed rail head suggest that the fatigue resistance of this section of rail was exhausted.

CN has increased the frequency of the visual inspection from twice a week to three times a week. SPC 3207 has been amended; it now includes criteria for remedial action for crushed rail heads.
